# भारत का राजपत्र The Gazette of India

“17 अक्टूबर, 2003 को मैसर्स सिंगरेनी कोलियरी कम्पनी लिमिटेड की कोयला खानों में हुई बड़ी दुर्घटना, जिसमें 10 लोगों की मृत्यु हुई, के संबंध में जांच अदालत की रिपोर्ट”

मैसर्स सिंगरेनी कोलियरी कम्पनी लिमिटेड के गोदावरीखनी सं. 8ए इन्क्लाइन खान में दिनांक 17 अक्टूबर, 2003 को घटित 10 व्यक्तियों की प्राणघातक दुर्घटना पर

जांच न्यायालय का प्रतिवेदन

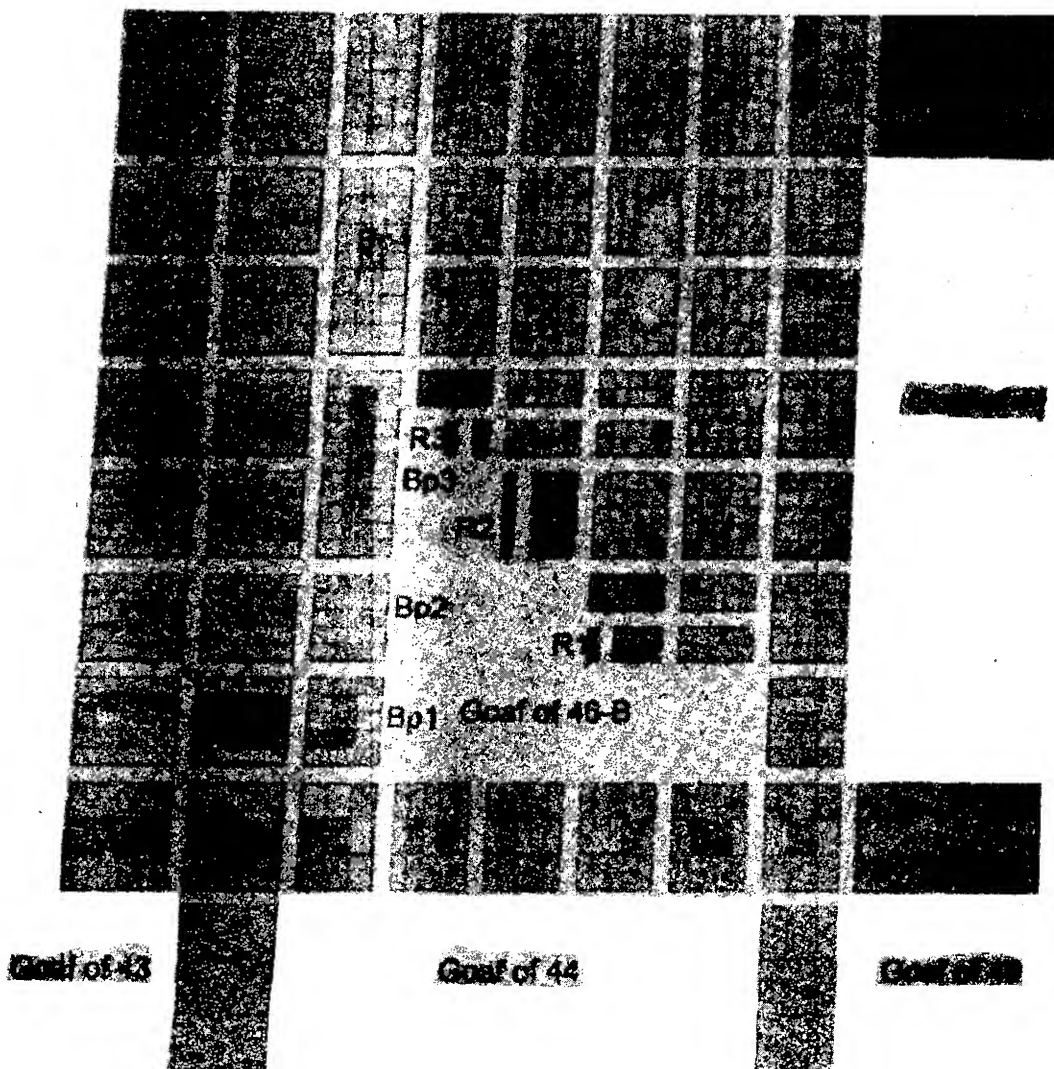
Fig7: Block contours of safety factor over different pillars of panel no 46 B with 46A panel only developed

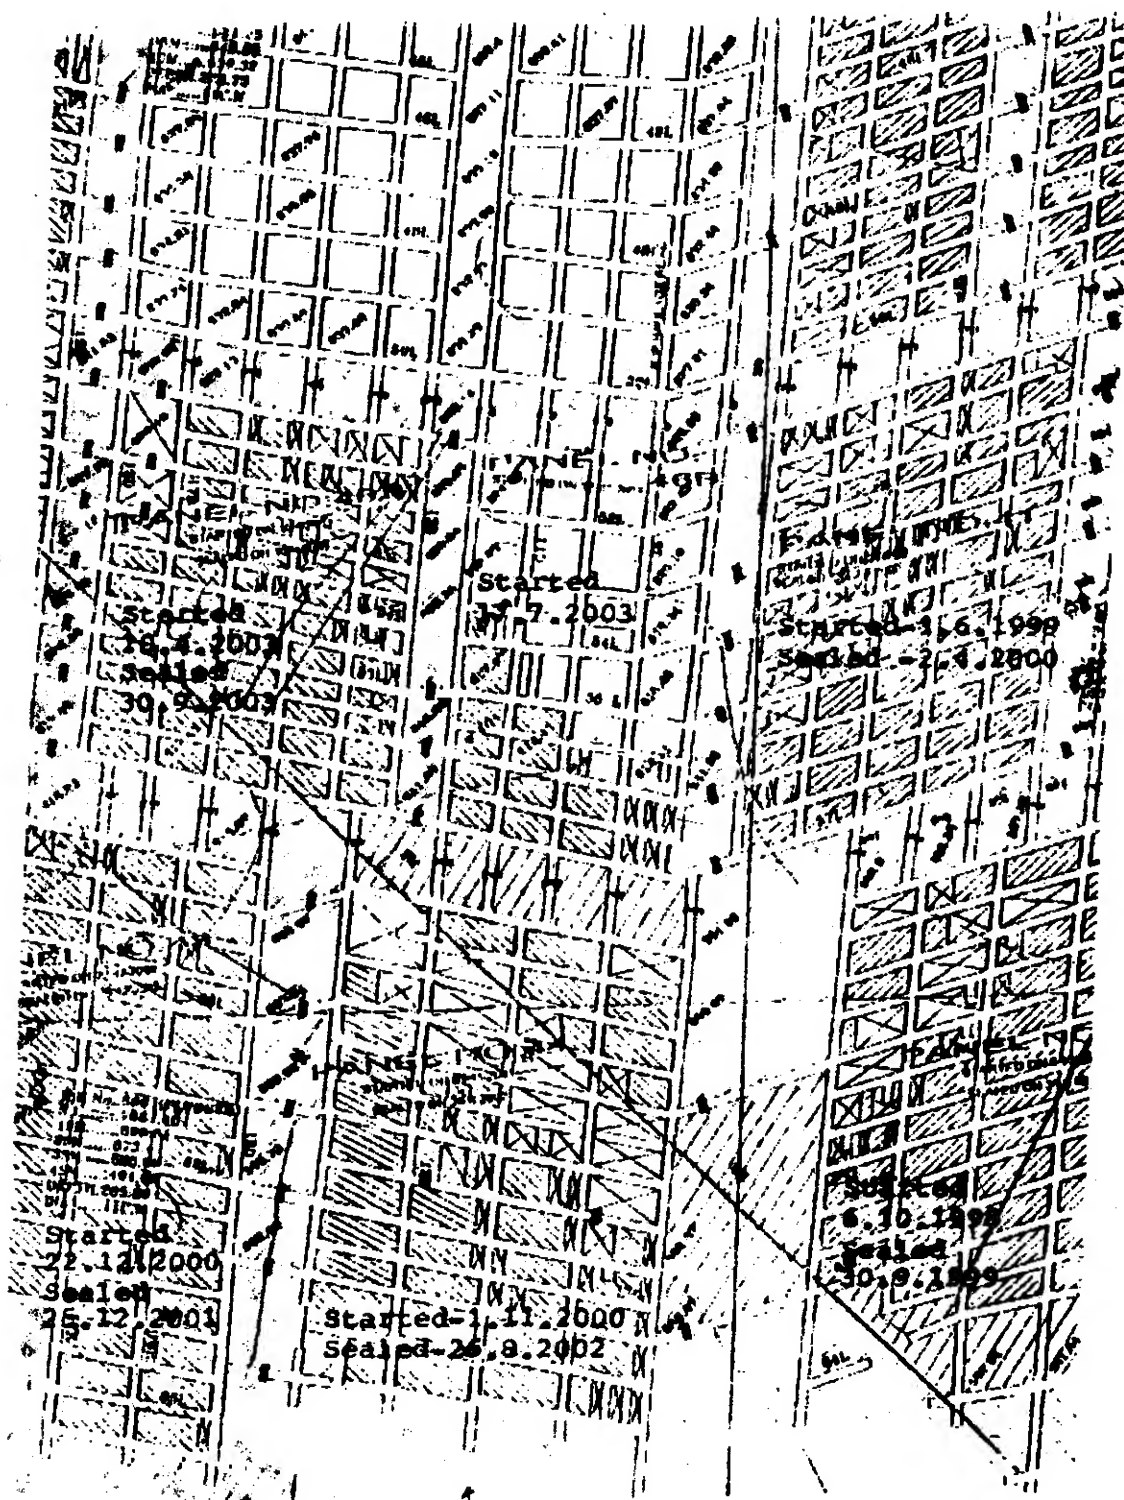
Fig.4 - Working prepositions of different panels  
at the time of accident in Panel No.46B.

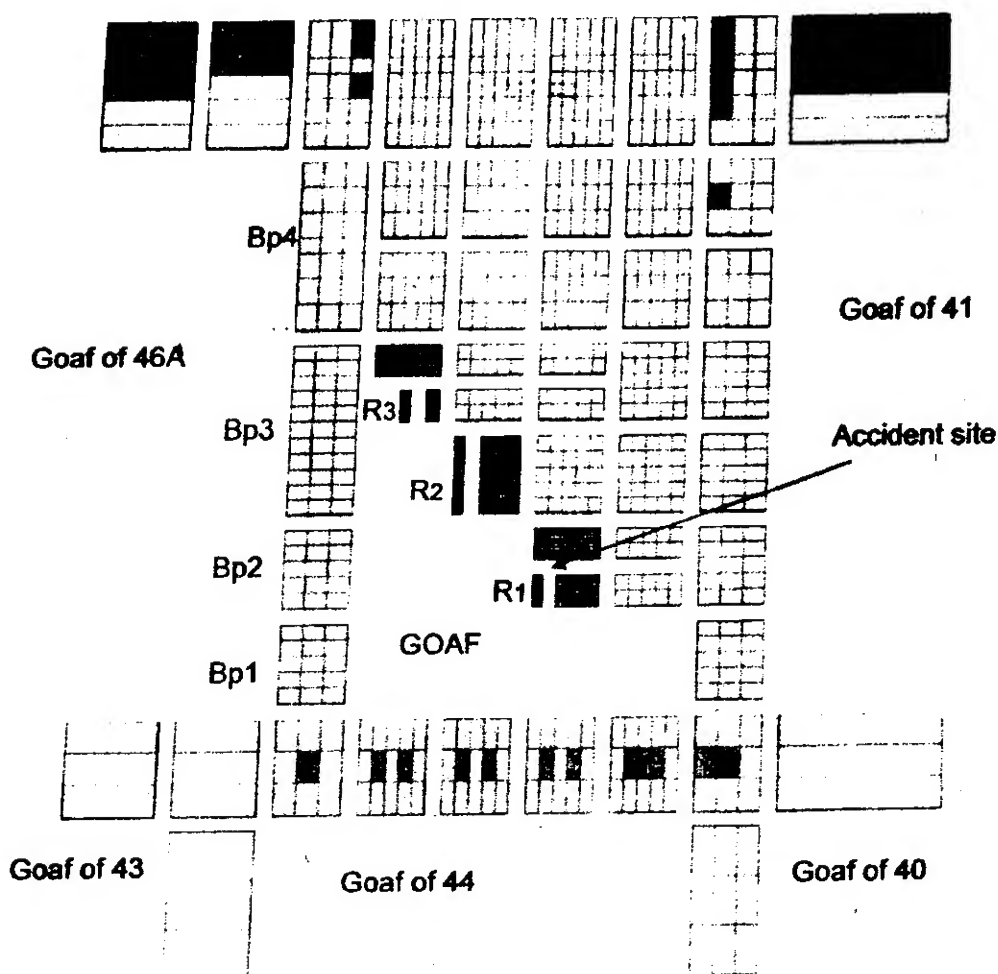
Fig. 6: Block contours of safety factor over the pillars with 3 sides of panel 46-B already extracted

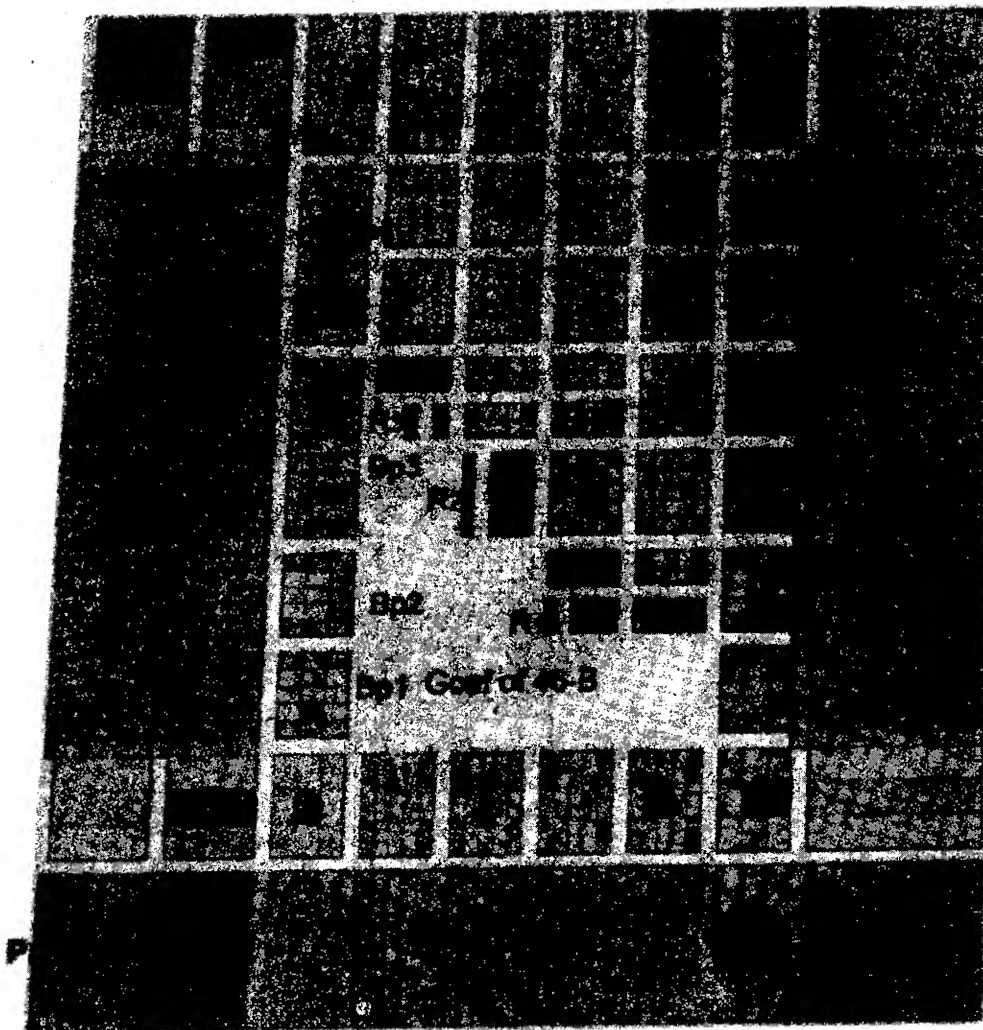
Fig. 8: Block contours of safety factor over pillars with 3 sides of the panel no 46-B was extracted but goaf was completely settled
